Walkability Study

City of Northville

September 20, 2021

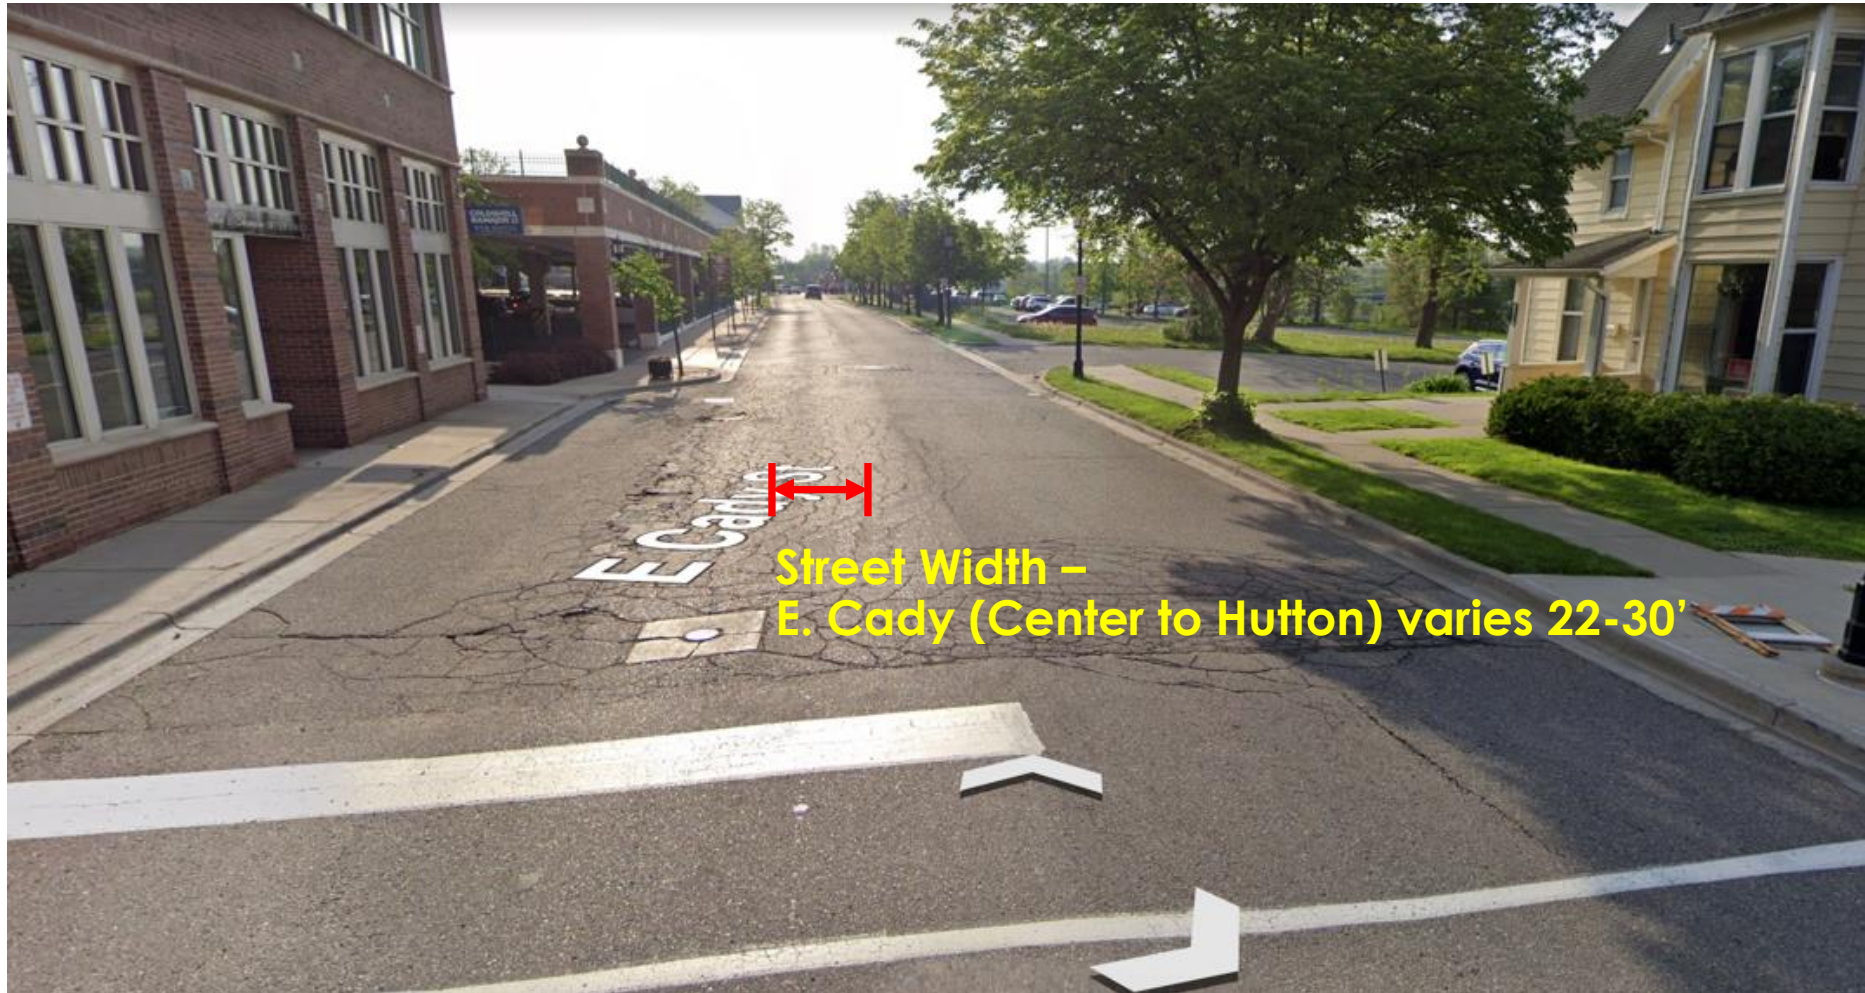
Figure 2B. E. Cady St. at S. Center facing east

Walkability is challenged due to the presence of a parking deck and multiple parking lots on the north and south side of the street. Rear views of buildings, lack of street trees, some lack of sidewalks, limited use of parallel parking spots and an office building with closed window shades at street level all negatively affect walkability.

Traffic calming measures are needed at Hutton and Church Streets to protect preschoolers and the new residents of the Downs development. Higher visibility crosswalks are recommended rather than current box style.

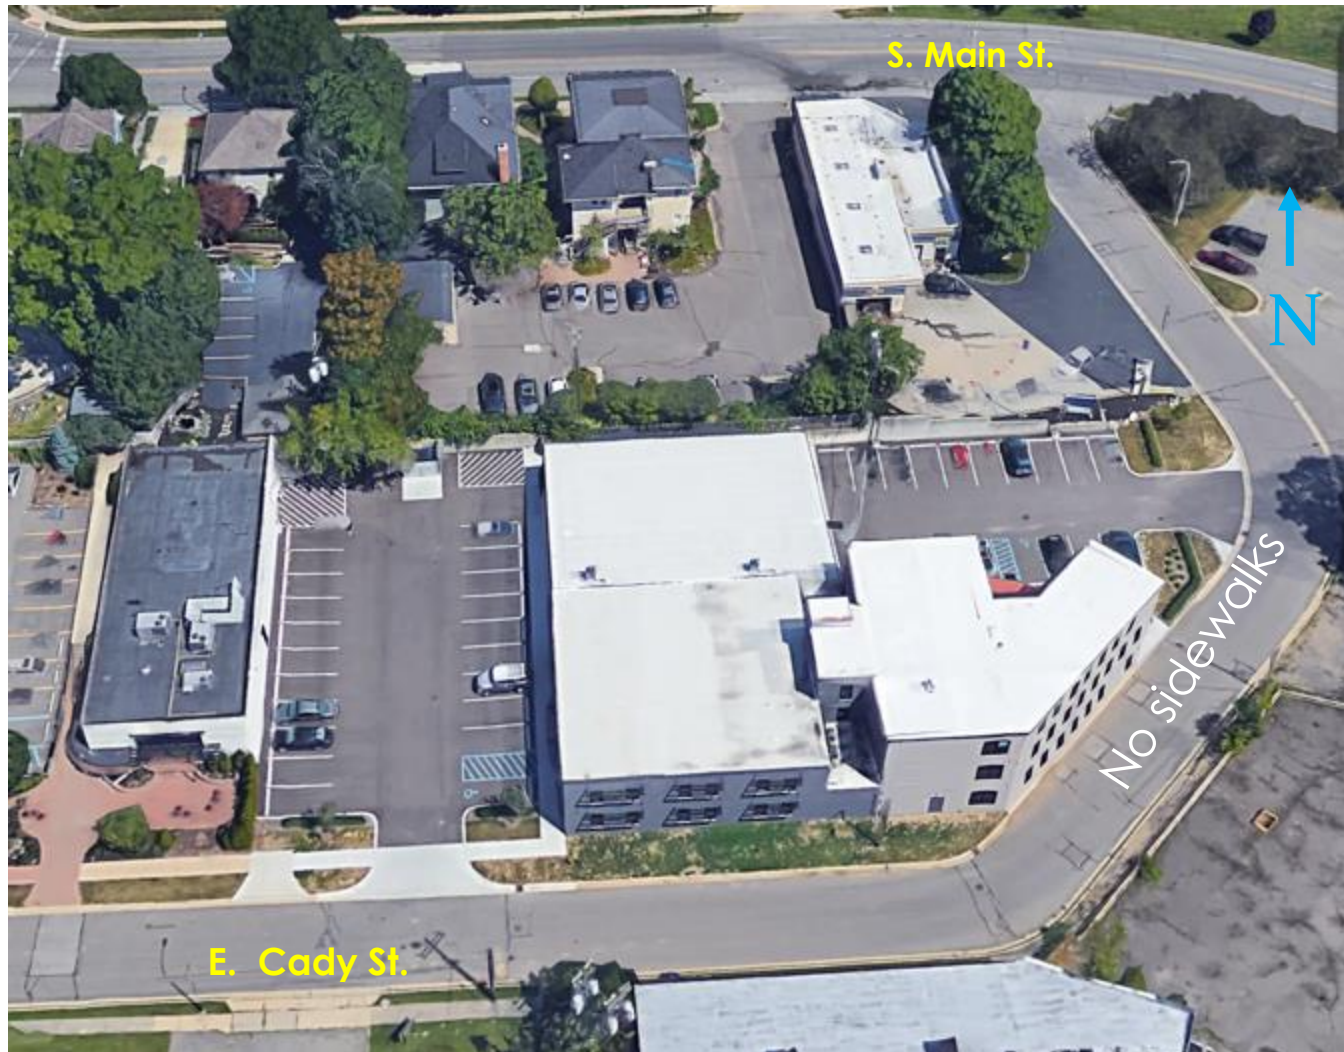
Figure 2D E. Cady St. - East of Hutton

E. Cady St. east of Griswold has low walkability. There are no sidewalks. The shape of this segment of the road, coupled with the location of its intersection with S. Main, is problematic for pedestrians.

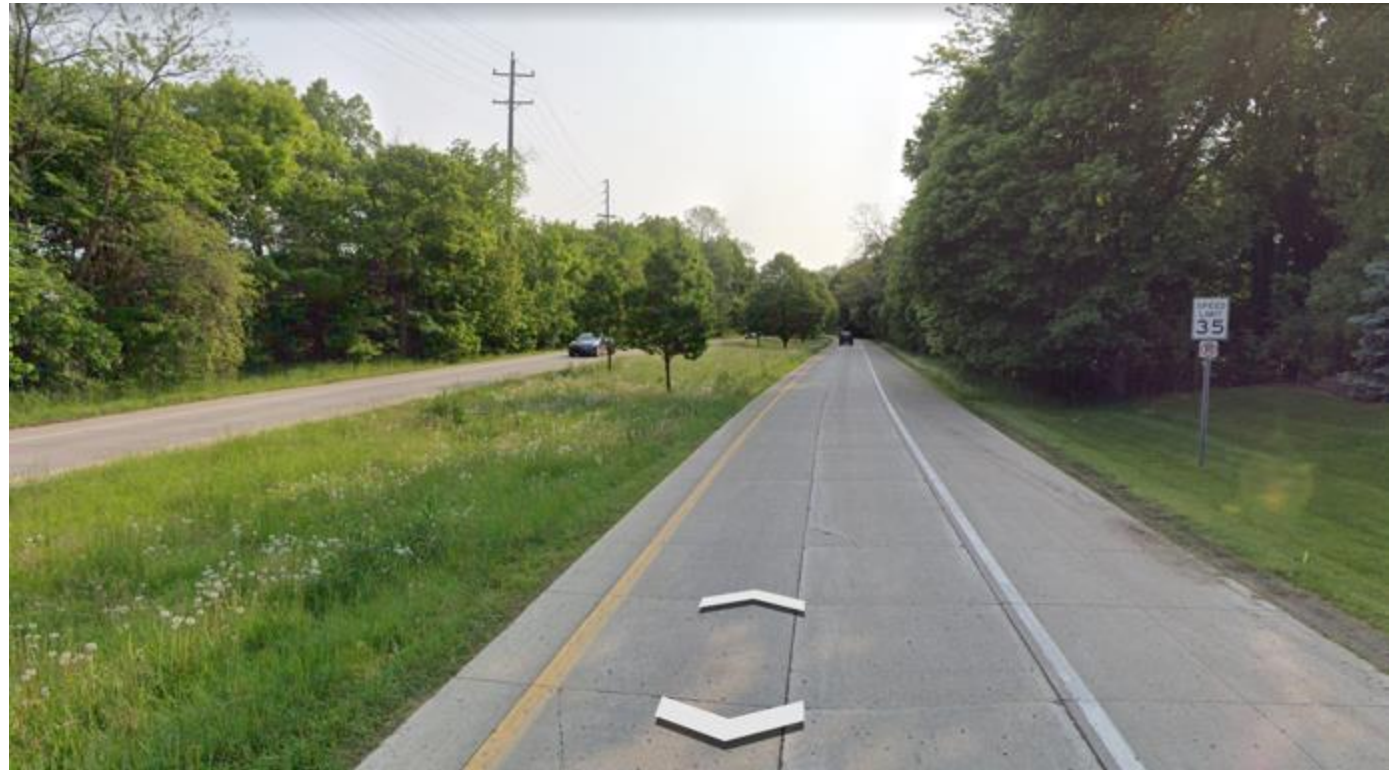
Figure 3B. Griswold (N. of Lake Shore Ln. & S. of 8 Mile Rd.)

- Single lane, boulevard street with limited-to-no sidewalks.
- Bike paths fairly consistent.
- Posted speed limit 35 mph. Street width 37'.

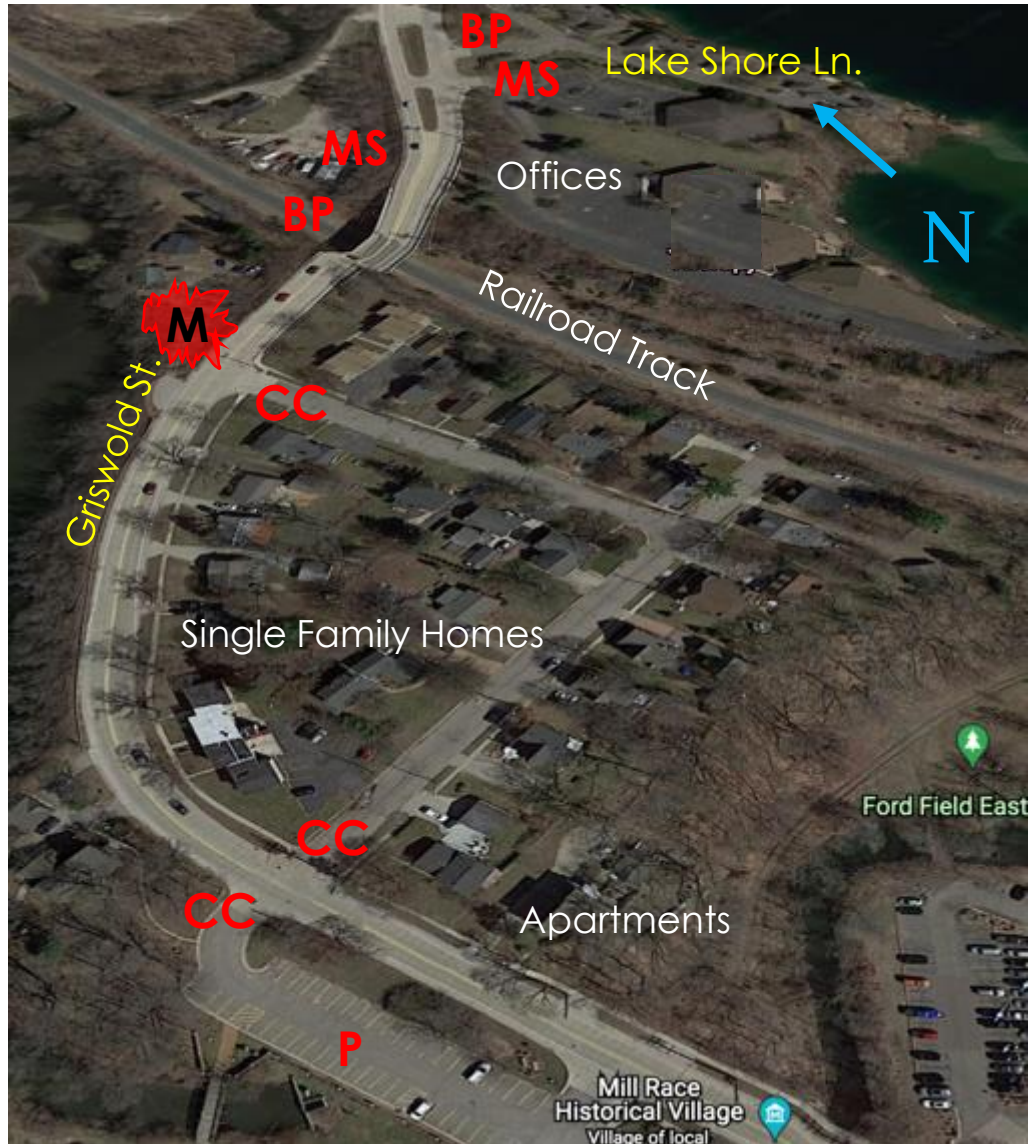
Figure 3C. Griswold (Lake Shore Ln. to Ford Field)

- Vegetation interfering with cyclist passage.
- Posted speed limit 35 mph.

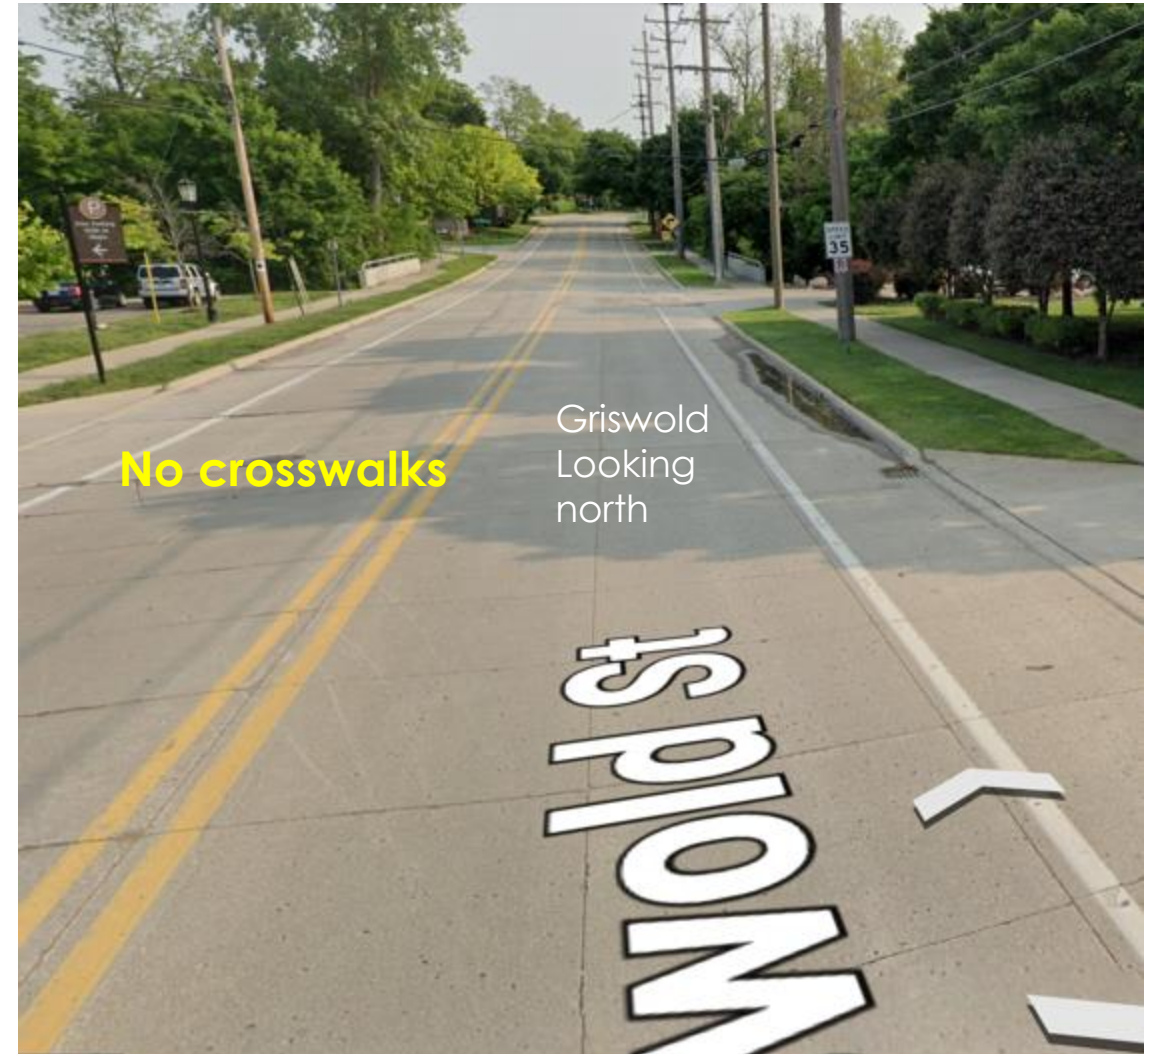
Figure 3G. Griswold showing lack of pedestrian crosswalks

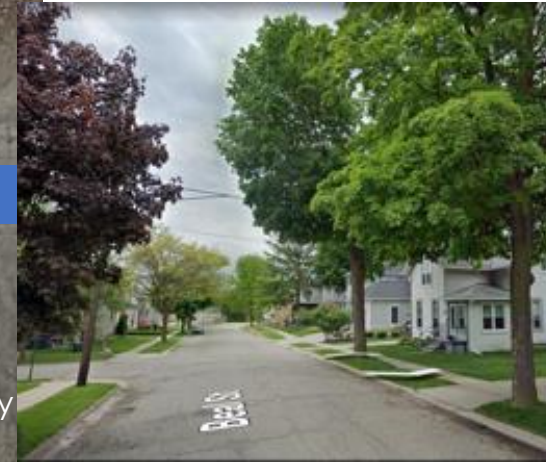
Figure 4A. Beal St.

With its mature trees, sidewalks and landscape buffer between the curb and the street, and the proximity to the river, Beal St. has good walkability. Efforts to mitigate high-volume quantities of traffic through this space should be promoted.

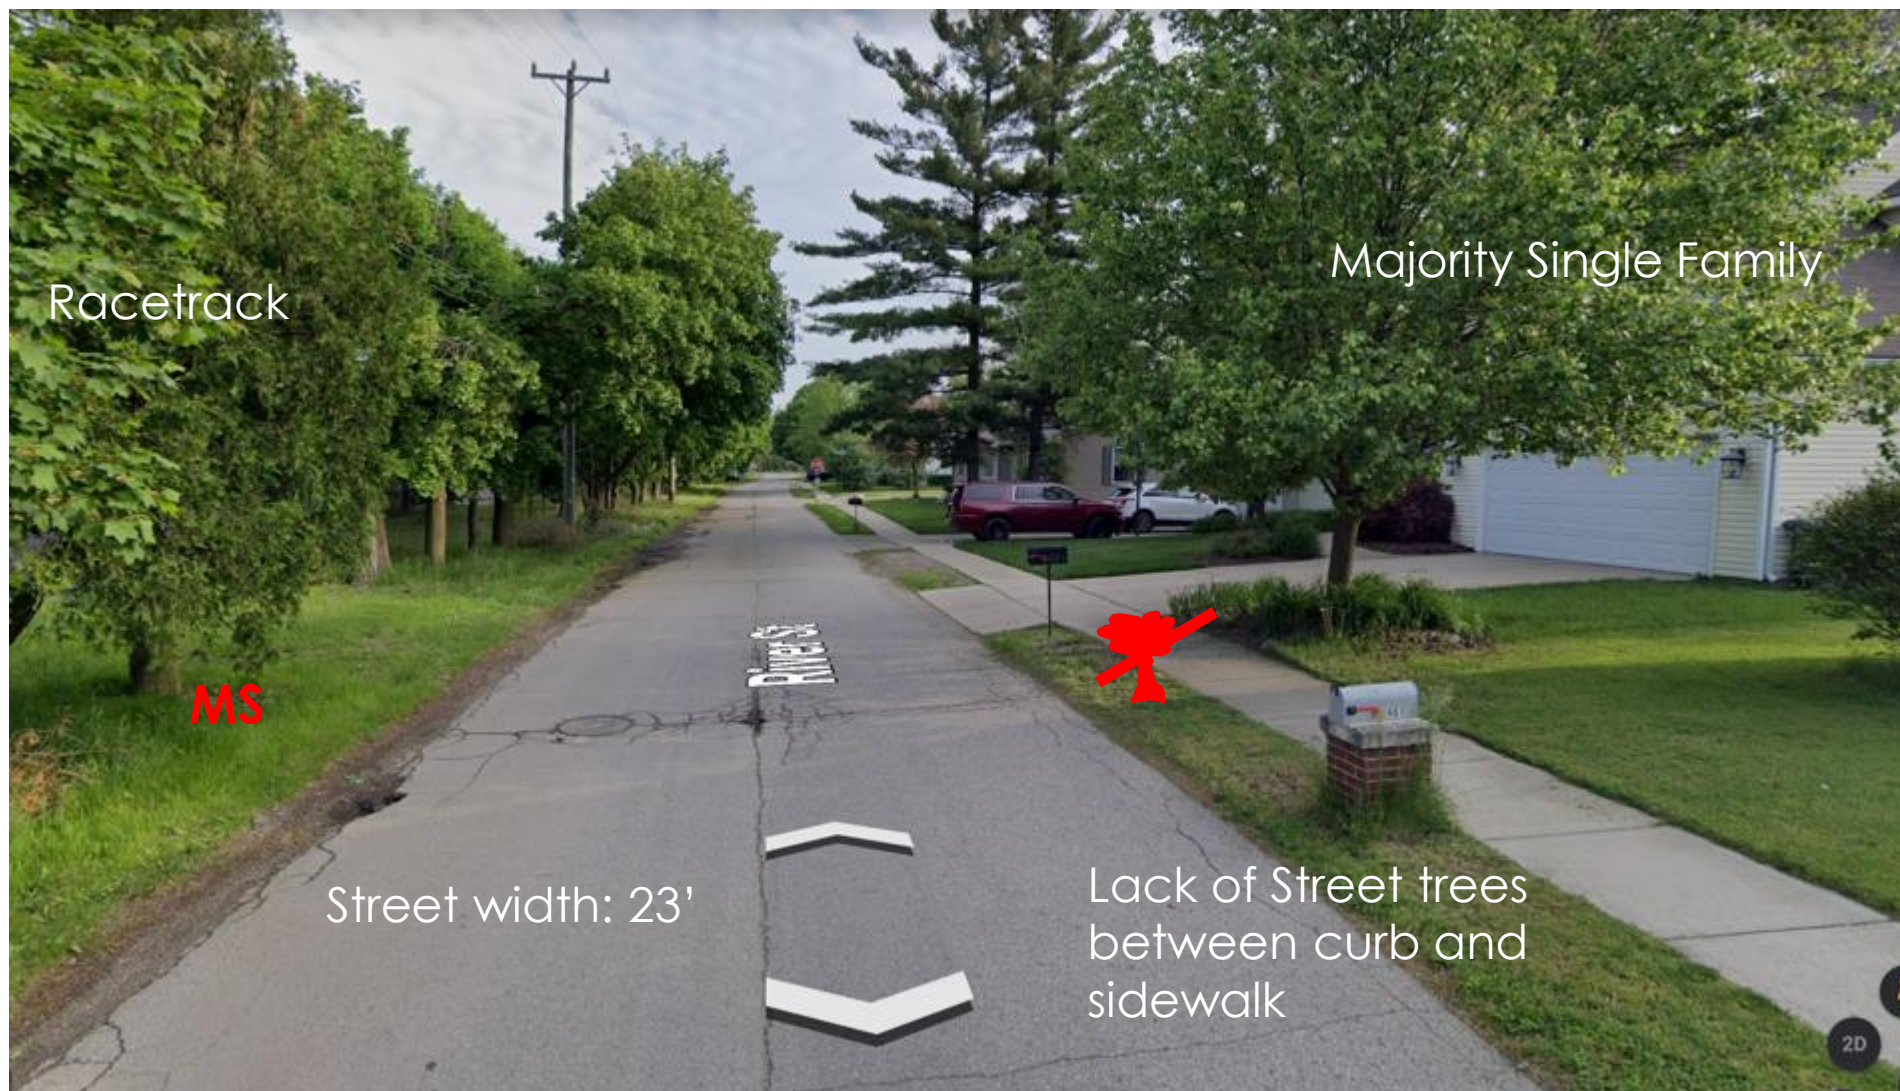
Figure 5A. River St. looking north

The right of way for River Street is narrow, with sidewalks on only one side. A narrow landscape buffer exists between the curb and the sidewalk, but there is a lack of street trees within this buffer. Several mature trees (in various states of health) are on the west side of the street.

Widening the right of way for River St. and coordinating a west-side path within the proposed park would improve walkability.

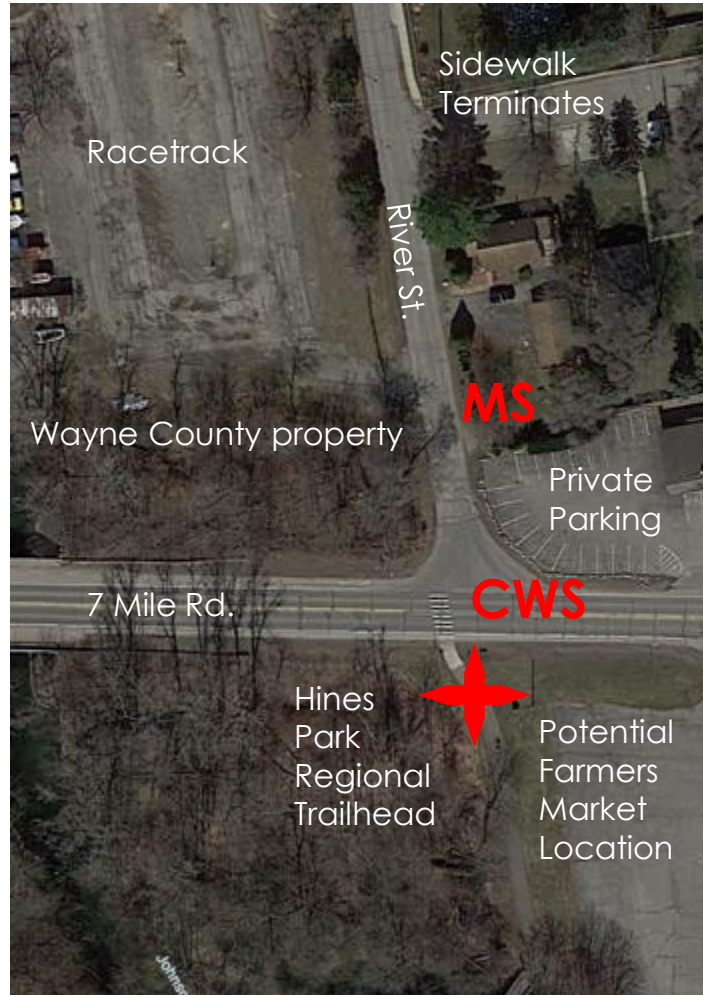
Figure 5B. Incomplete, regional trailhead with no sidewalk connection

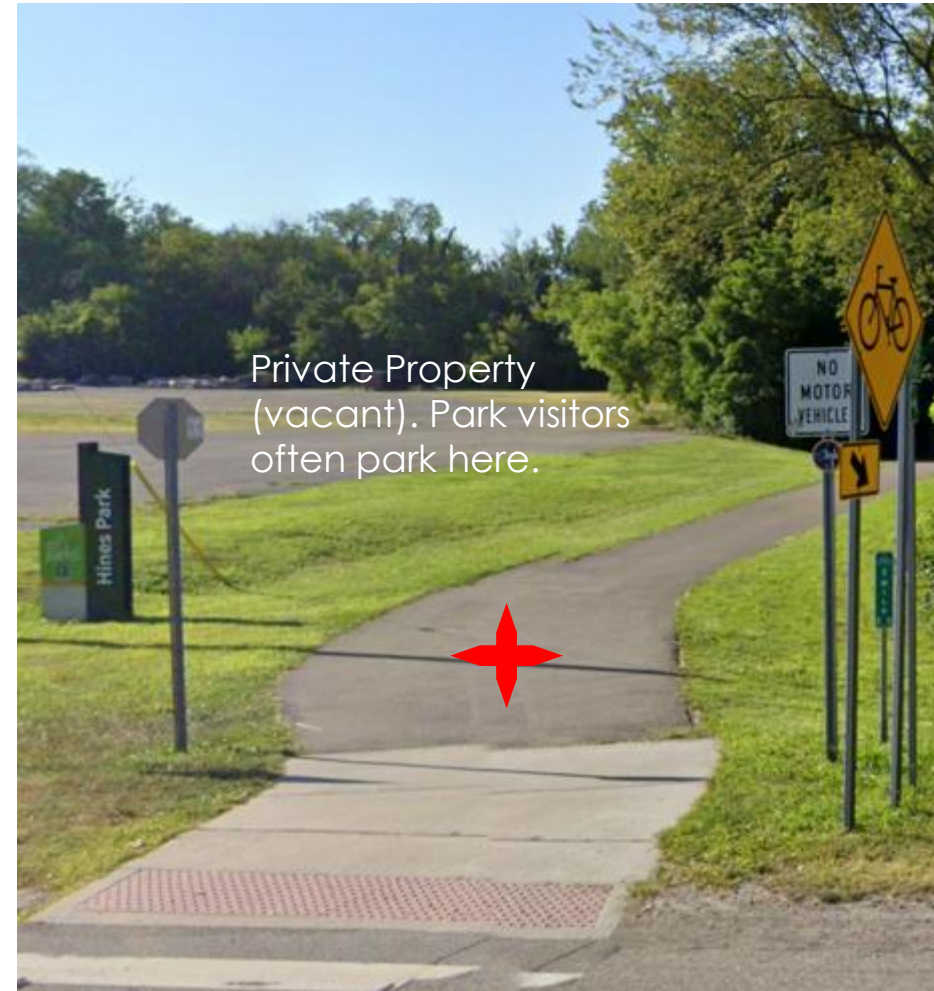
Figure 5C. Entrance to regional park system with no adjacent public parking

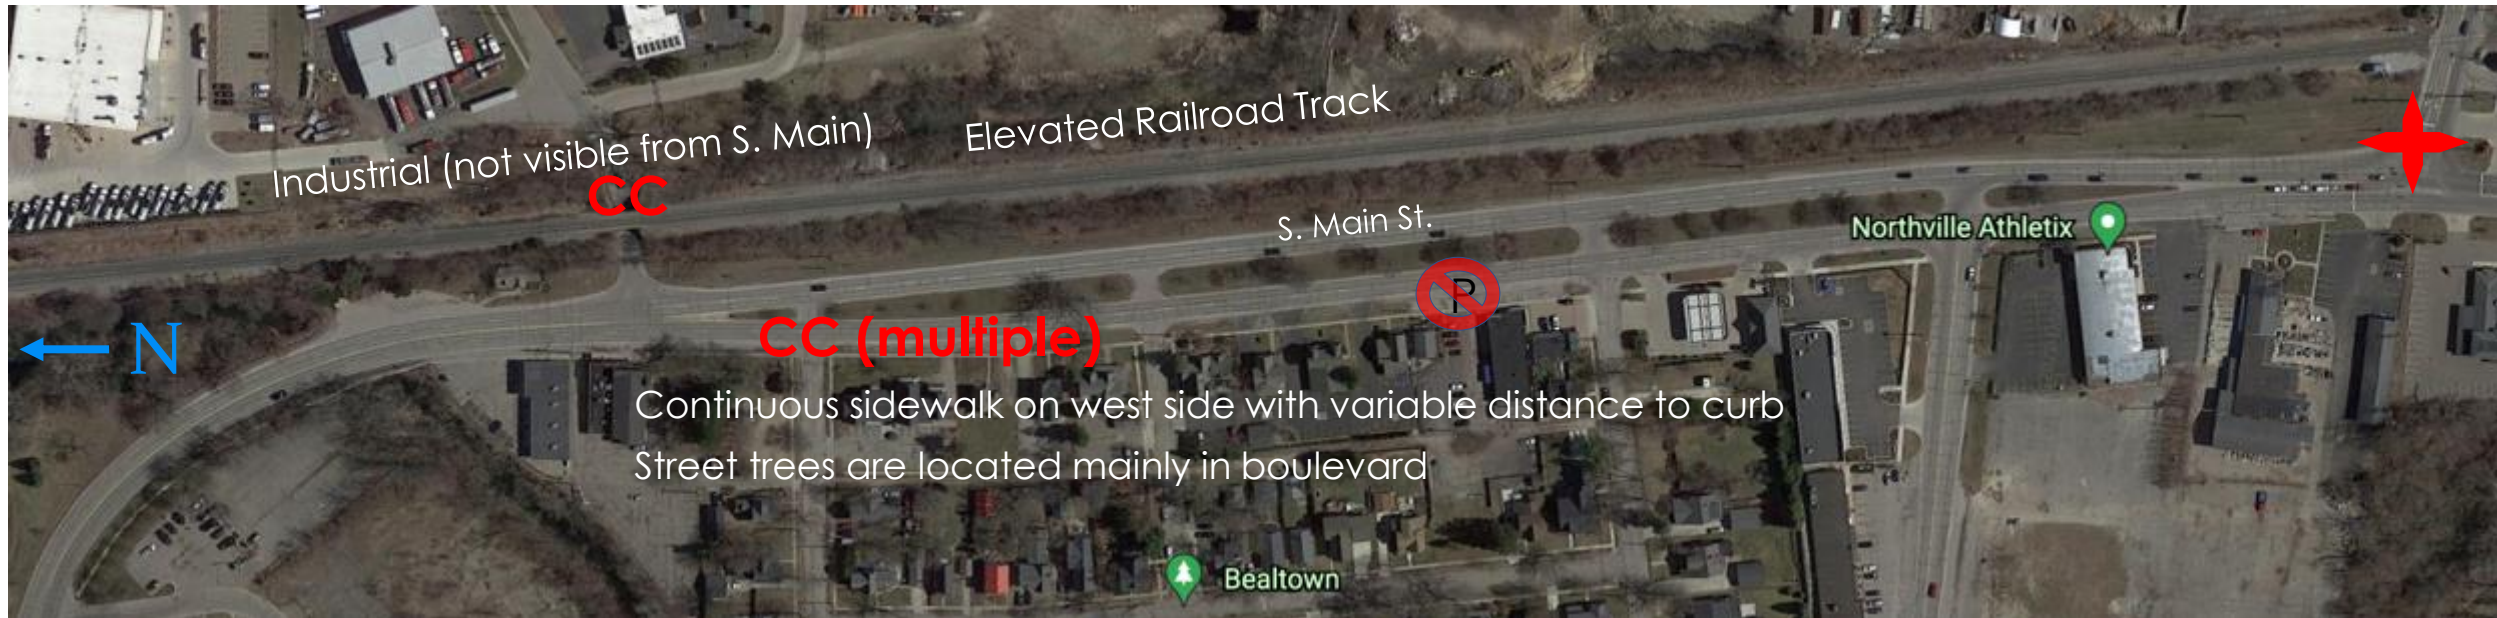
Figure 6B. Traffic volumes do not warrant 4 lane roads. Minimal infrastructure to protect pedestrians from vehicles. Wide lanes encourage speeds in excess of posted limits.

Traffic volumes do not justify the need for 4 lanes with widths greater than 11 feet. This is one of the few areas of the city that is well-positioned to restripe and redeploy the streetscape in order to provide biking, pedestrian and parking capacity.

Professional design expertise is warranted to redesign the striping for paths and parking

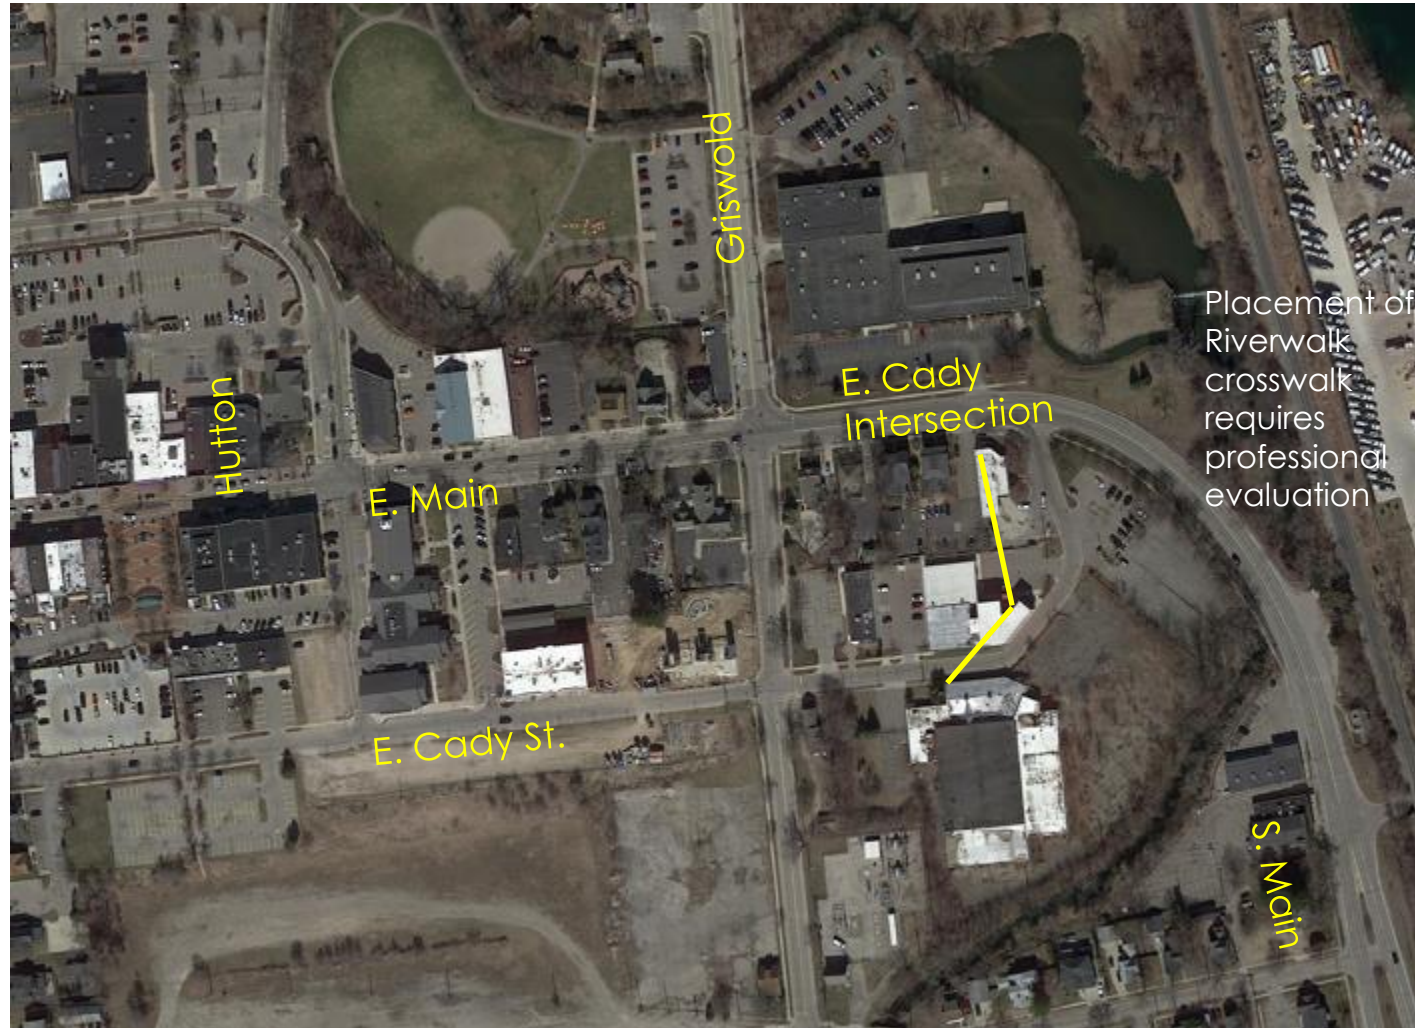
Figure 6C. The wide width of S. Main, coupled with a large curve radius, encourages higher-than-posted speeds. Limited visibility to E. Cady St. intersection creates less reaction time, which negatively affects pedestrian safety.

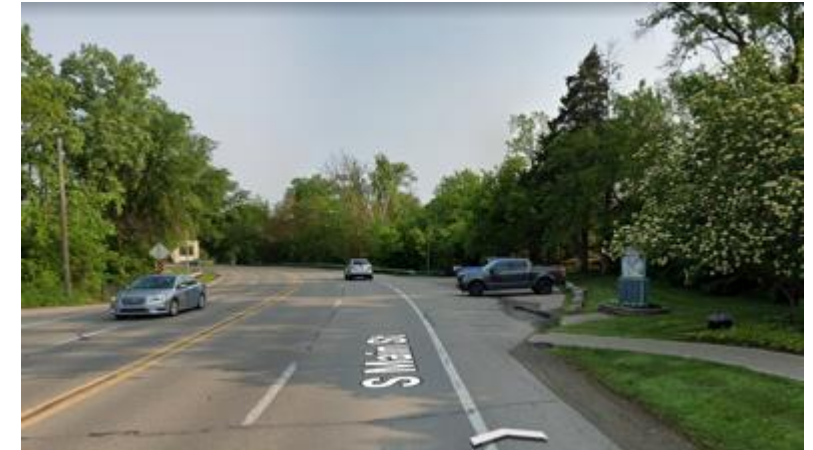
Figure 6D. S. Main entrance to downtown is a 4-lane curve (25 mph posted speed)

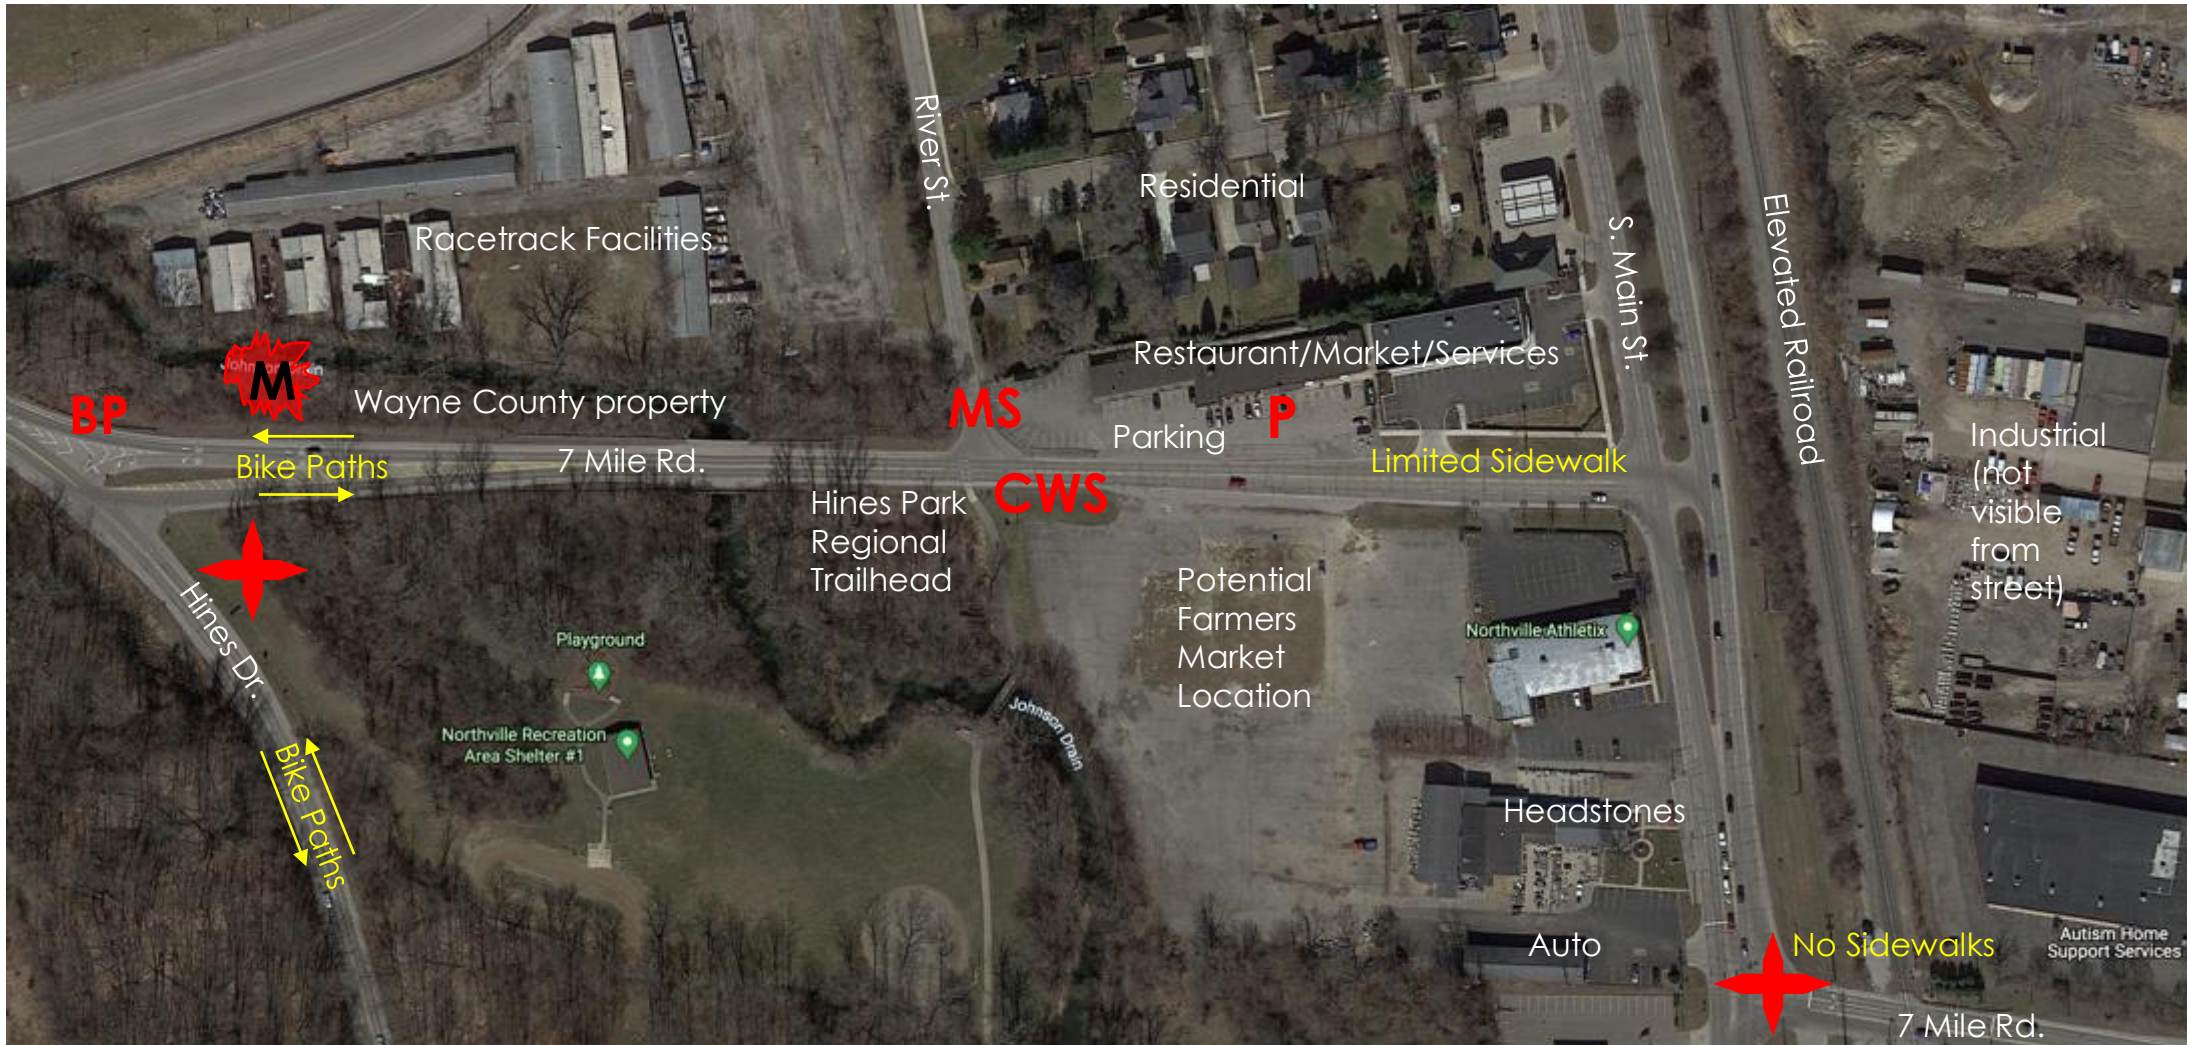
Figure 7A. Regional bike paths converging with partially complete, non-motorized infrastructure

Cyclist/pedestrian safety is a major issue. Crosswalks have low visibility and are missing. Vegetation encroaches into bike paths. Connectivity of Downs development with Hines should be considered to break up the “superblock” and improve intersection safety. Appropriate signage would improve motorist awareness of cycling lanes.

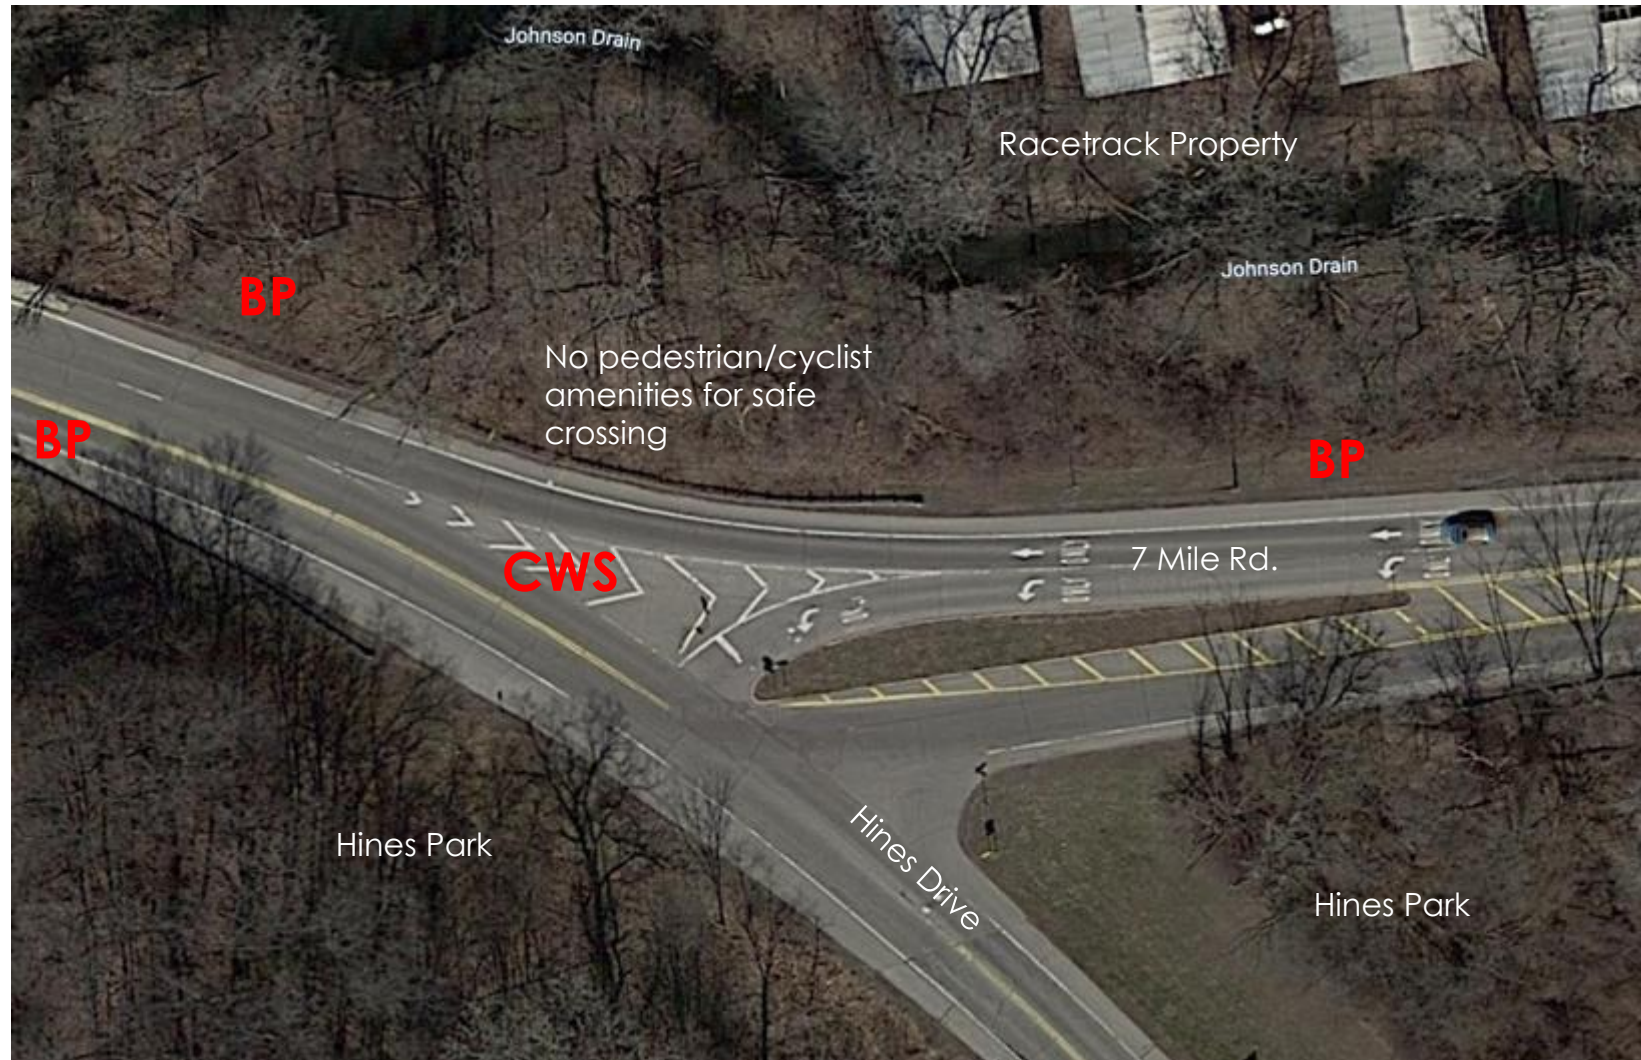
Figure 7B. Regional bike paths converging with partially complete, non-motorized infrastructure

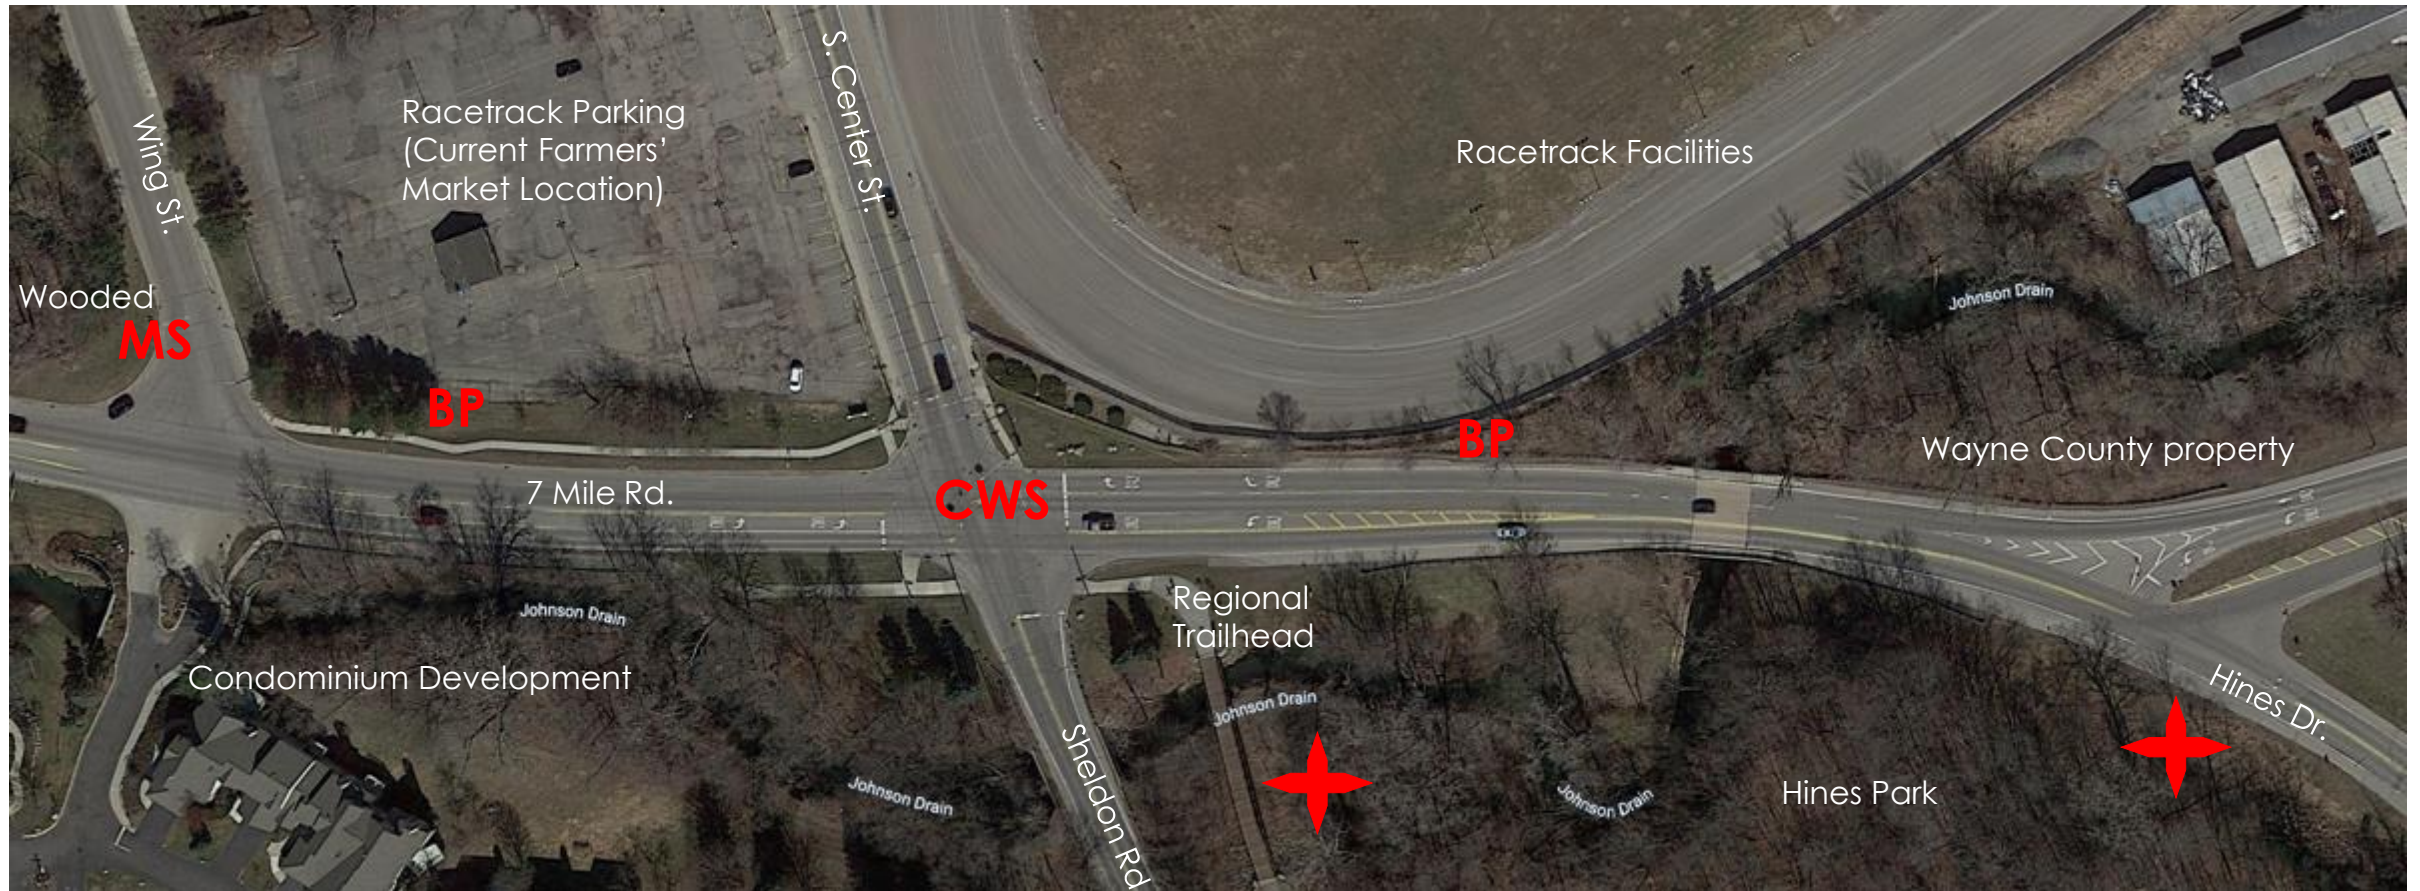
Figure 7C. Intersection Safety

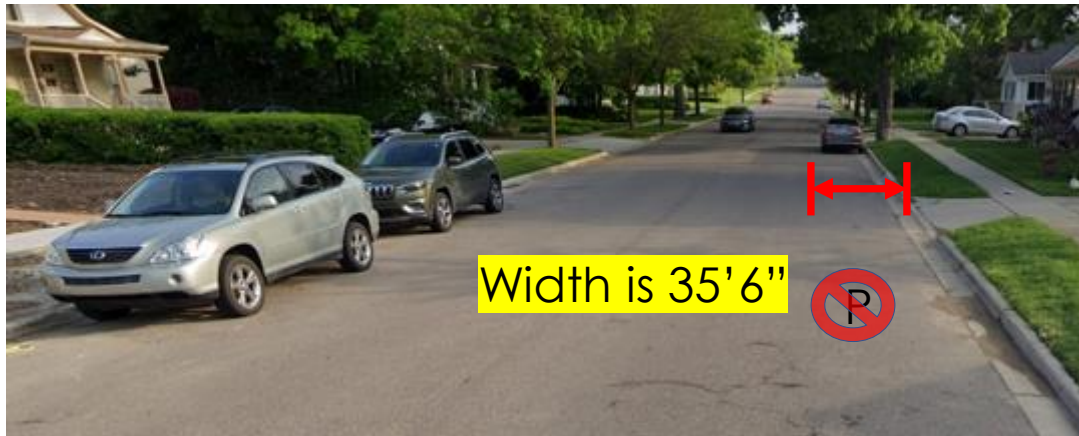
Figure 8B. Wing St. looking north

Sidewalks exist on both sides of the street with the exception of a single-loaded sidewalk south of Fairbrook St. Street trees have a variable presence, ranging from none to newly-planted to mature.

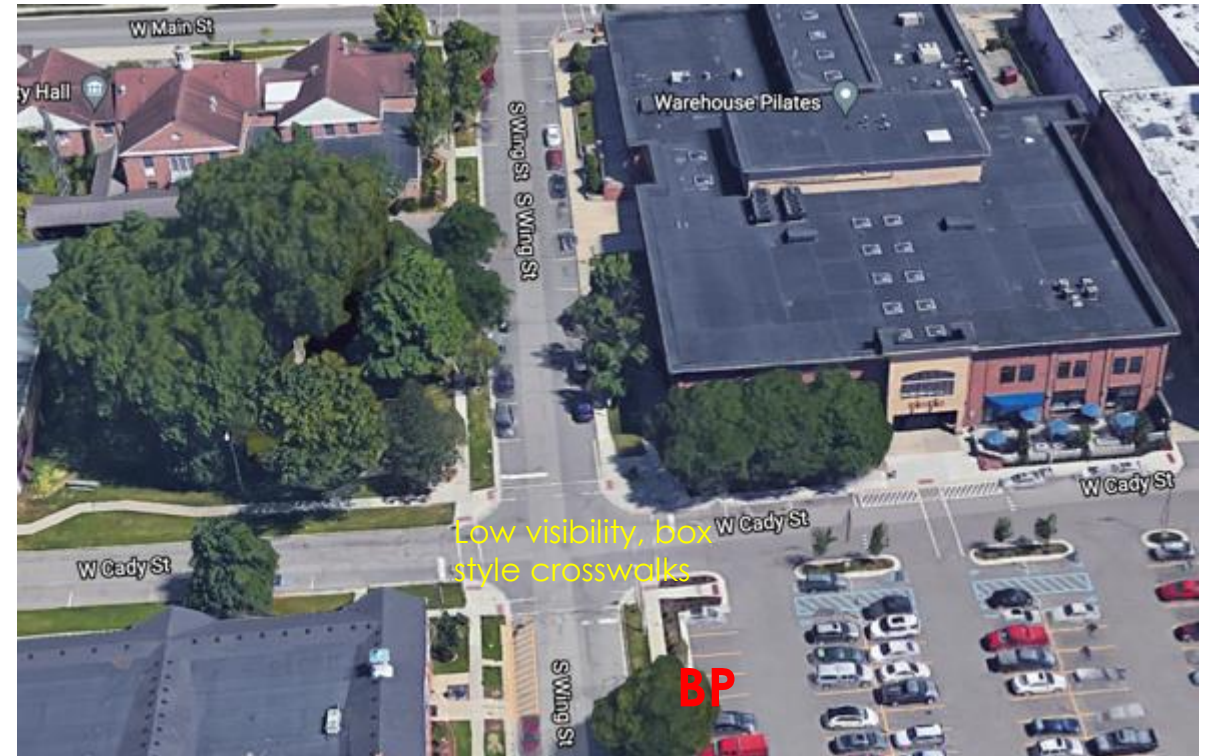
Figure 8C. Wing St. with parallel parking on both sides N. of West Cady Street

The right-of-way is ample enough to accommodate parallel parking, but only a small portion is striped and actively used. This increases the perceived lane width for drivers, which in turn, encourages higher speeds, which negatively impacts pedestrians and cyclists.
