Walkability Study

City of Northville

September 20, 2021

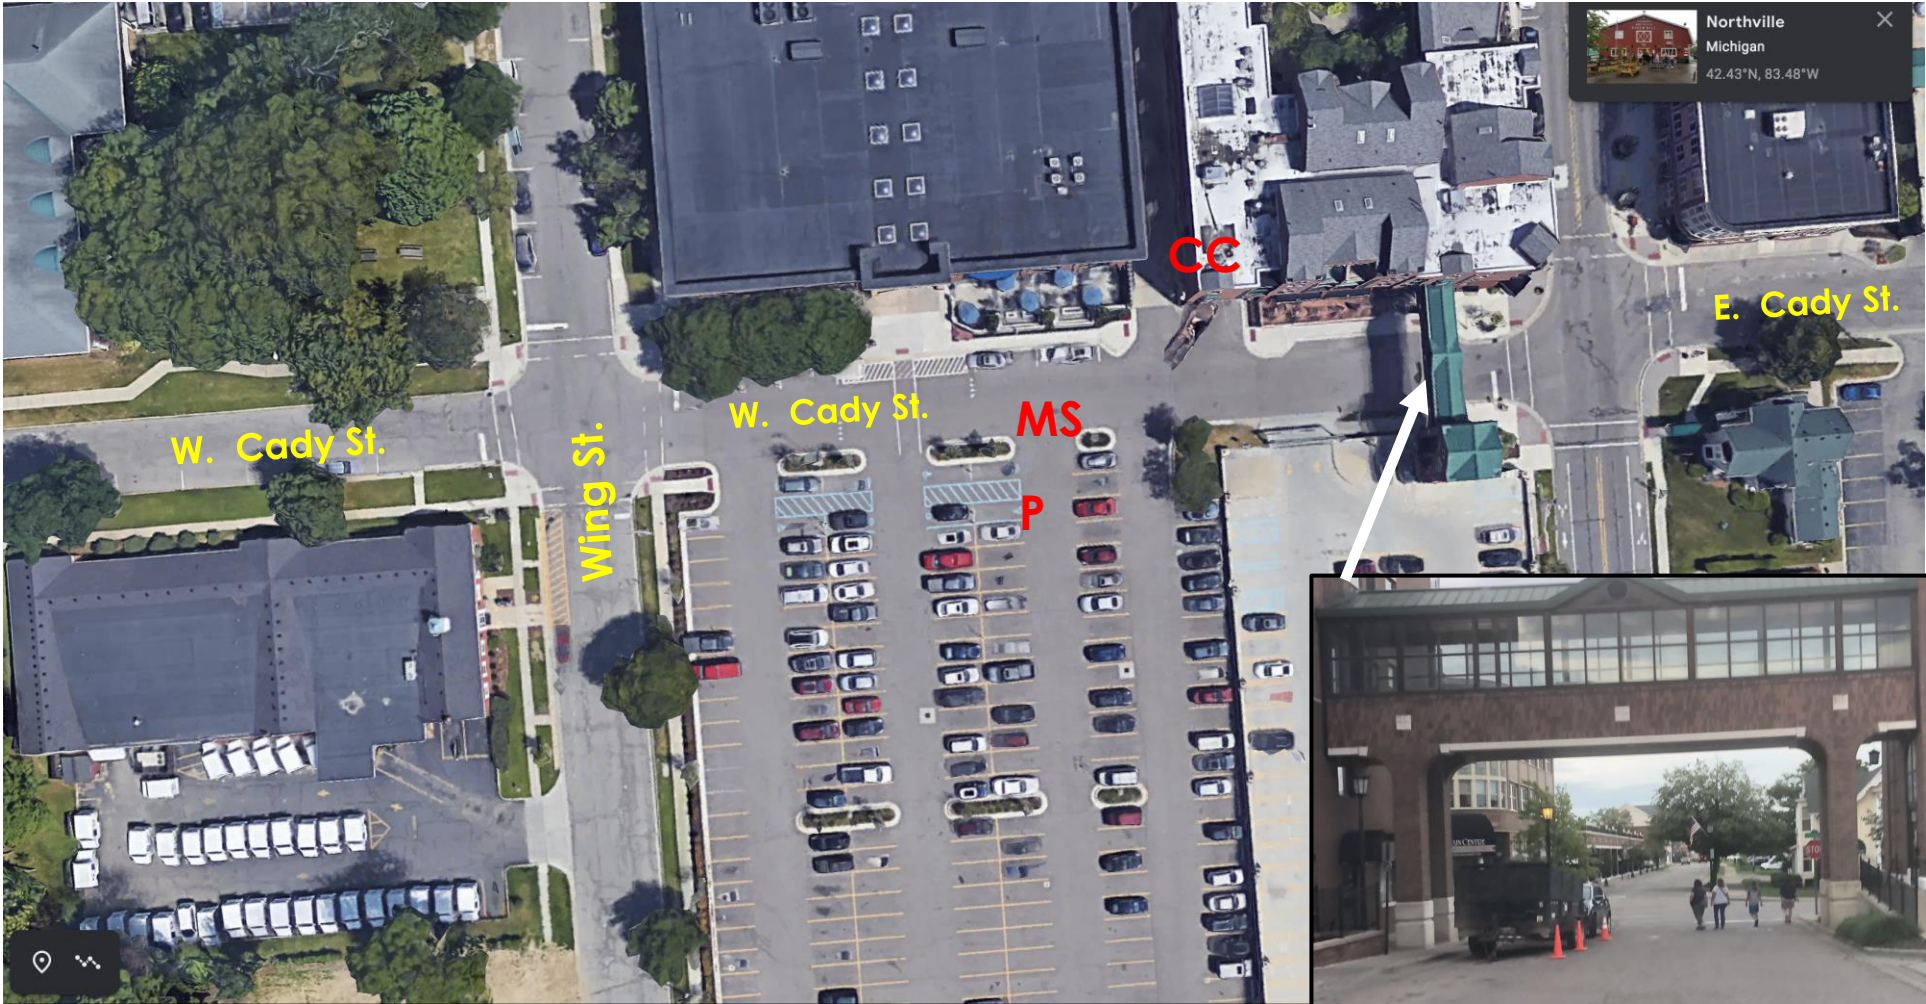
Figure 9A. W. Cady St. Wing Street Parking Area

There is a significant lack of sidewalks. Pedestrian traffic is high due to close-proximity of the parking lot to downtown, the Post Office and the Northville Square building. Walkability safety in this area is a concern.

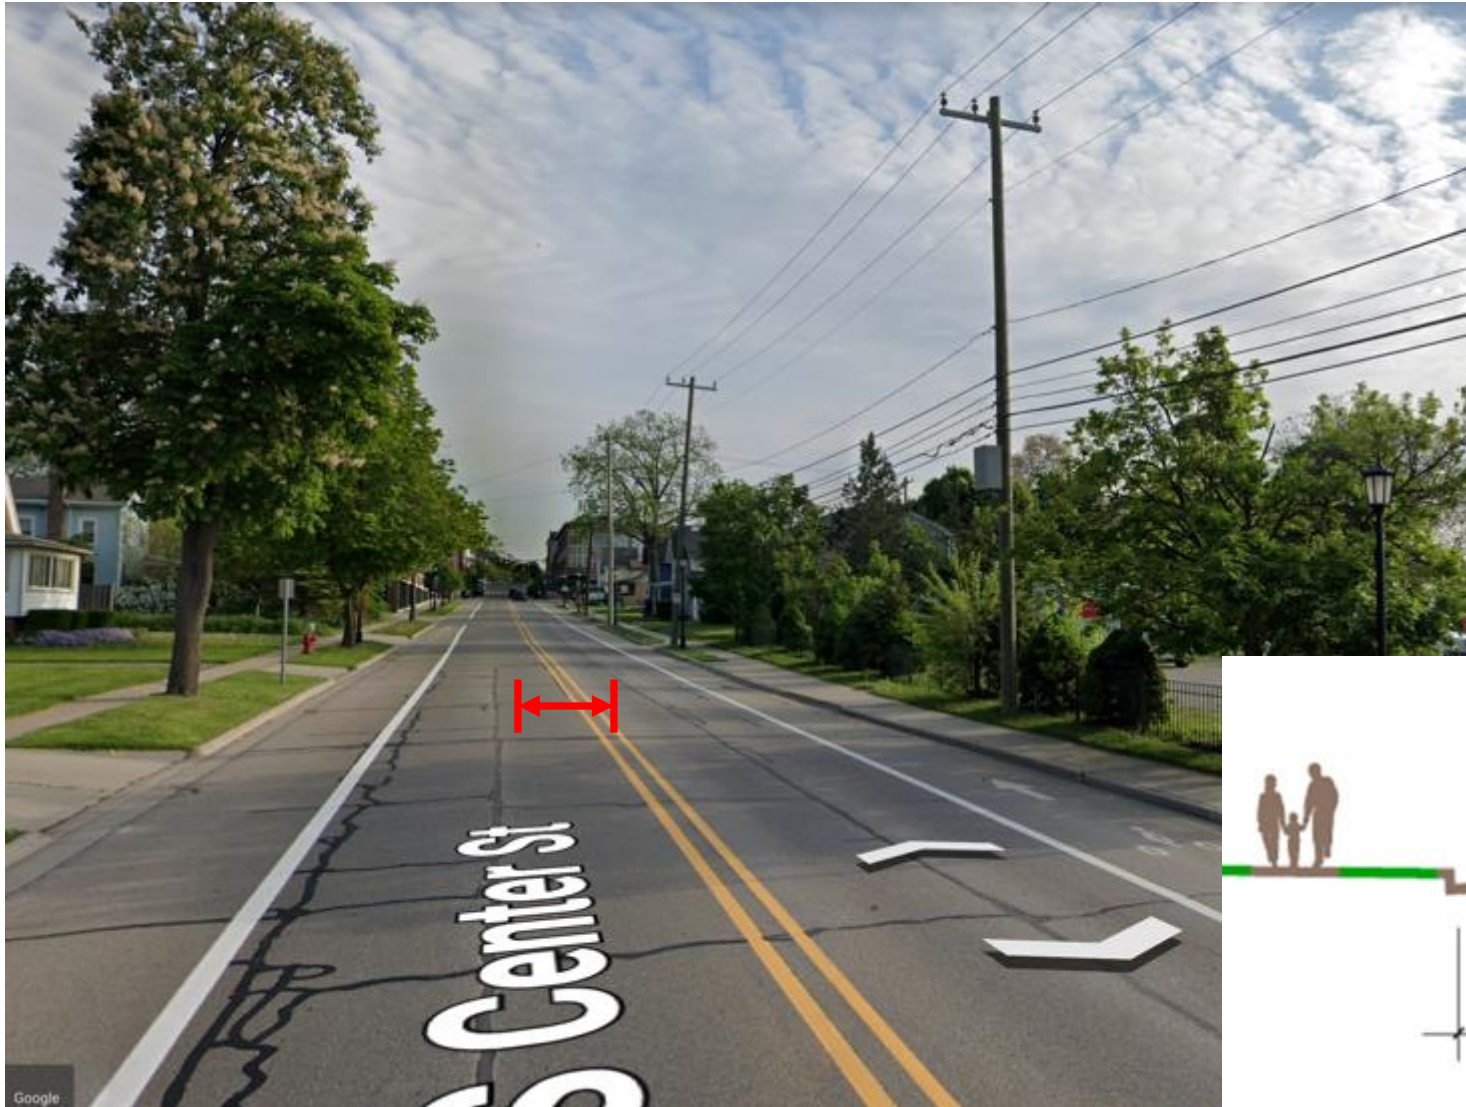
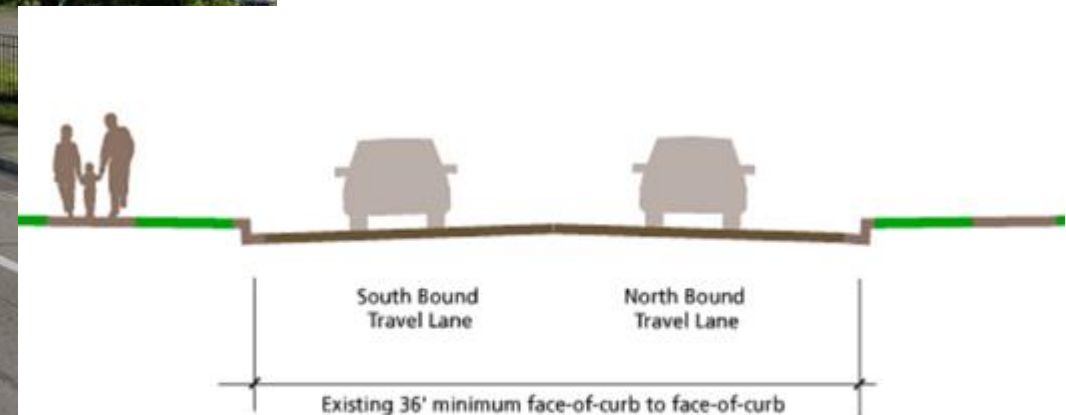
Figure 10C. S. Center looking north

- Street width: 40'
- Lane width: 14'
- 6' Bike lane both sides
- No parallel parking
- Racetrack side - no buffer between sidewalk and curb
- Racetrack properties lack street trees
- Posted speed: 35 mph until Cady St., then 25 mph

S. Center Street from Seven Mile to Cady
typical existing cross section

- Since the proposed development of this street is mainly residential, consideration should be given to lowering the posted speed limit to 25 mph and also to determining if parallel parking could be established.

- Additional traffic calming alternatives include a boulevard and/or landscaped buffers between the curb and the sidewalk.
